8 November 1989

November 6, 1989

Report of a Dye Study to Determine the Source of the North Direct Discharge

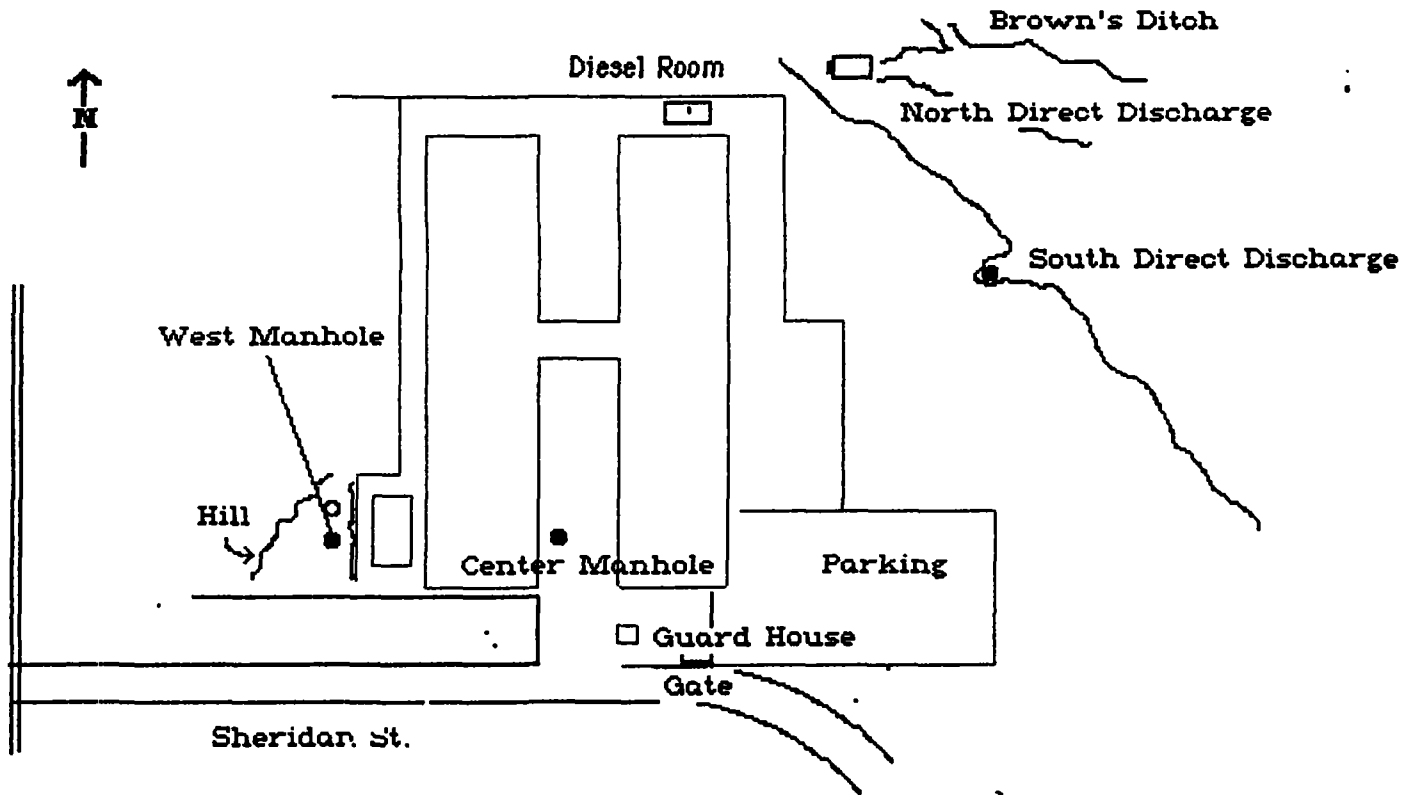
Figure 1..

The team (Rich Nicholson, Tim Miller and Russ Norton) proceeded to the emergency diesel generating room (Figure 1) where a five-gallon bucket of fluorescent dye was prepared and introduced into the floor drain; simultaneously a team member was positioned at the outfall to detect the presence of dye. Following a six-minute interval during which no dye was observed at the outfall, a second bucket of dye was prepared at a higher concentration and also introduced into the floor drain. Within two minutes, traces of dye were observed at the discharge which steadily increased in concentration, as indicated by the intensity of fluorescent green color. The conclusion, therefore, is that the floor drain in the diesel generating room is directly connected to the north direct discharge.

I would also like to add that the diesel system which he speaks of has had a drip pan made specially for the motor to alleviate any further problems with the oil draining into the discharge system.

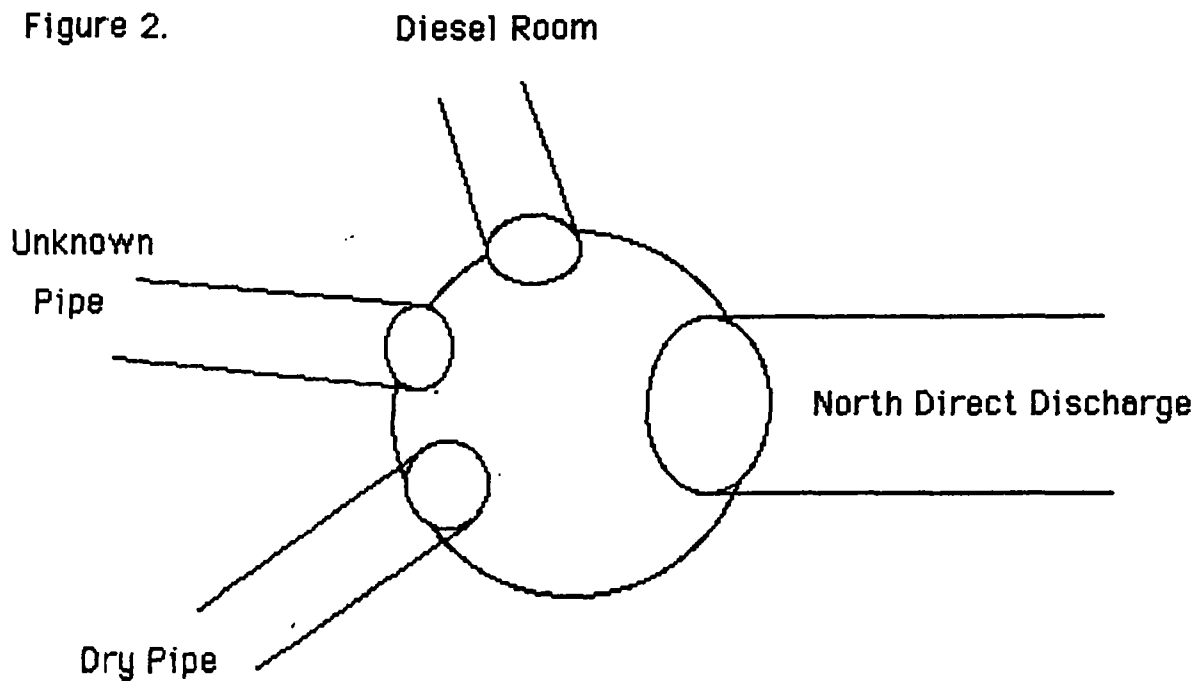
Figure 2.

To confirm this finding the EAL team entered the 48-inch discharge pipe and proceeded upstream for approximately 50 feet to the base of a manhole chamber. At this junction three 24-inch pipes combine to form the north direct discharge (see Figure 2). The north pipe leads to the diesel room as evidenced by the presence of dye. The south pipe was dry and appeared to have been for some time. The center pipe was discharging approximately two times the volume of the diesel room pipe and the submerged cross section of the pipe was coated with a 1/8-inch thick gray/white sludge.

On October 12, 1989 Rich Nicholson re-visited the site to obtain grab samples from each of the 24-inch feeder pipes, and the north direct discharge, to be analyzed for pH and oil and grease. The results are presented in Table 1. The flows were substantially reduced from the previous day which may account for the low oil and grease levels measured on October 12. It is difficult to determine from the present data the contribution of the unknown center pipe to the oil and grease levels occasionally measured in the north direct discharge.

To further define the source and character of the north direct discharge the EAL staff proposes to visit the site again in November 1989 at a time when discharge flows are expected to be higher, and to: 1) re-sample each 24-inch pipe and analyze for pH and oil and grease, and 2) attempt to identify the source of the center pipe by additional dye tracing studies.
